Report No. NATF(SI)-EI-115

6 May 1965

## AIRFIELD TELEVISION CONTROL CENTER MOBILE UNIT EVALUATION

BUREAU OF NAVAL WEAPONS  
PROBLEM ASSIGNMENT NUMBER RSSH-99-059/204/8

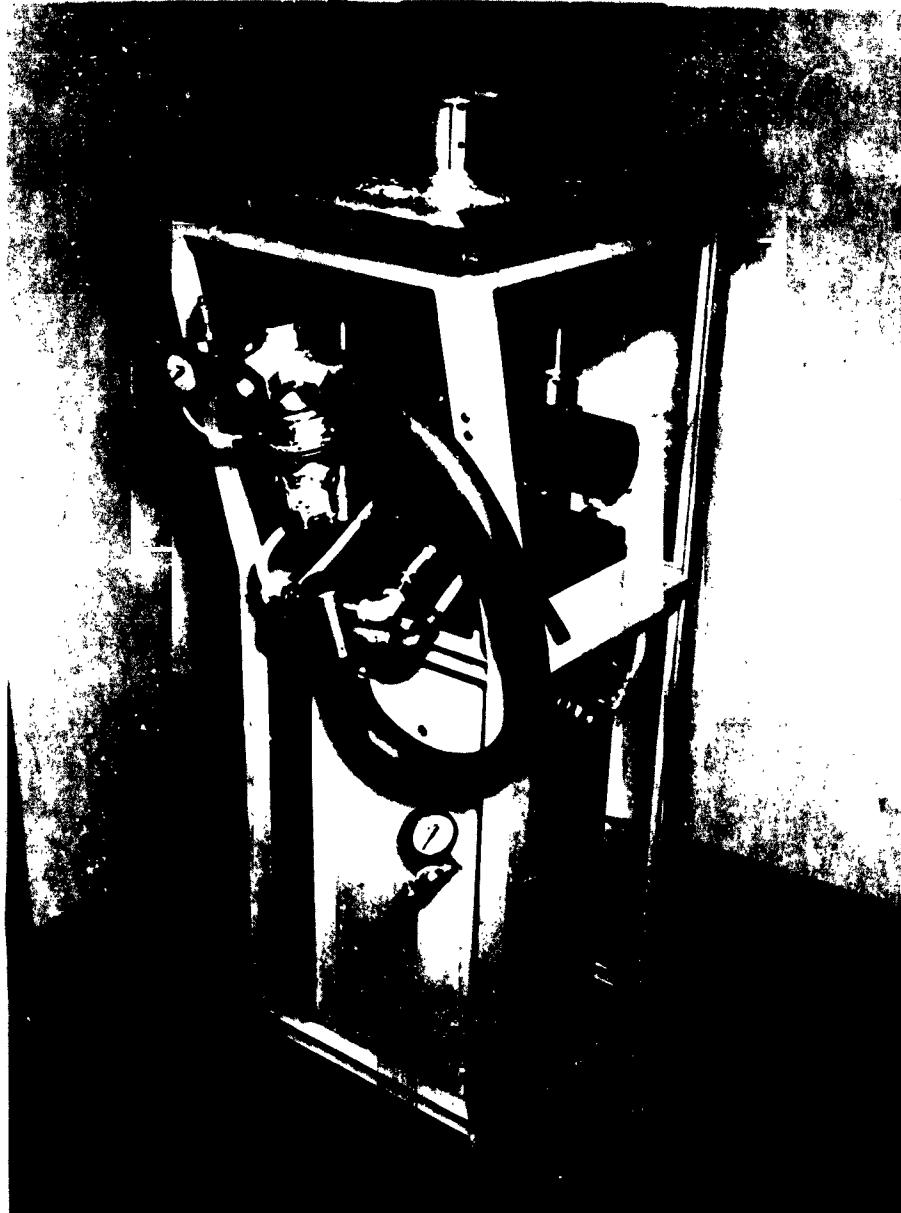
(1) One camera with extend/retract mirror assembly and variable glide-slope presentation capability is installed in a pit on the F-104G site runway centerline, 685 feet from the approach end of the matting. A special matting section is required for installation. The pit also contains equipment to heat or cool the camera to maintain proper operating temperature. A sump-pump installation is provided to keep the pit dry. Located to the left side of the runway and connected to the pit by two underground 6-inch pipes is a waterproof enclosure. This enclosure contains an air compressor for operating the pop-up mirror assembly and the centerline camera, ventilating fans for the camera pit, and circuit breakers for equipment in the waterproof enclosure and pit. (See Figures 1, 2, and 3.)

Figure 2 - Centerline Camera and Its Associated Equipment

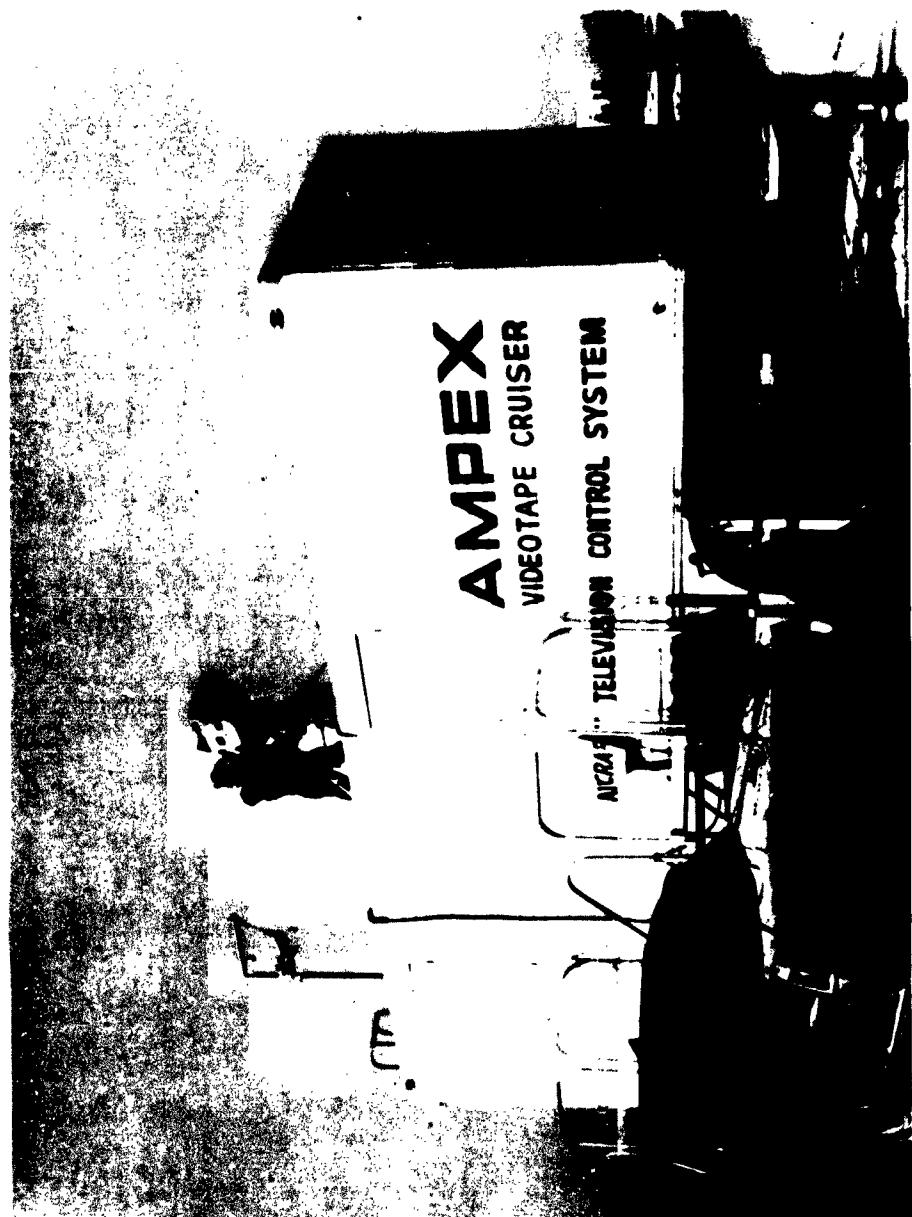
(e) Heating is adequate for personnel comfort and for equipment performance; however, the thermostat should be relocated further away from the exit door. Tests were conducted during the cold-weather portion of the year; therefore, the air-conditioning system could not be evaluated for hot-weather operations. Lighting is not adequate and should be improved for servicing equipment and reading manuals. In addition,

Figure 4 - Airfield Television Control Center Trailer

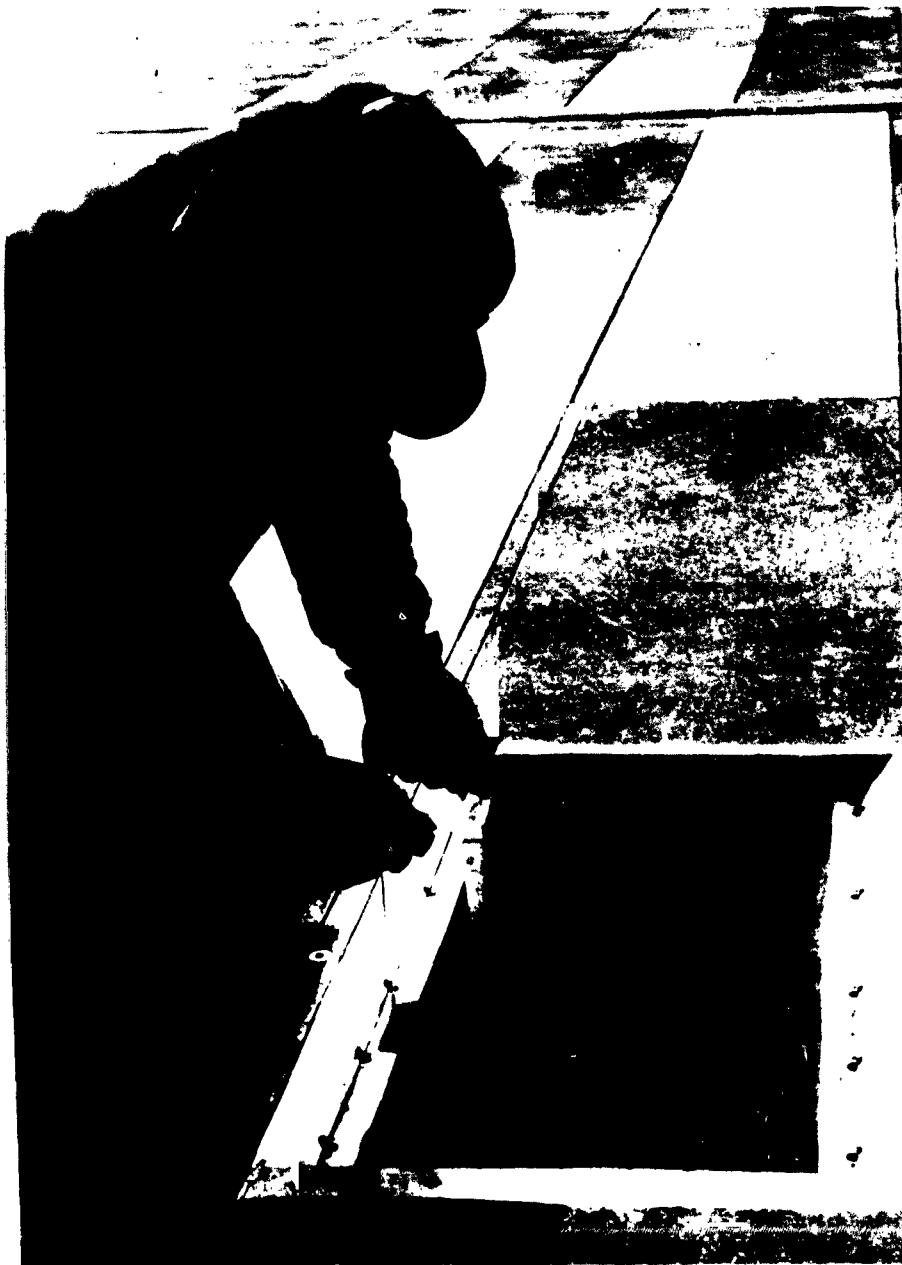
(j) From a maintenance standpoint, the centerline camera and equipment is too large for the present-size pit. Further, a NATF(SI) field modification (see Figure 13) was necessary to enable accomplishment of camera installation and removal. Some metal was removed to allow the reticule lamp housing to pass through.

Figure 13 - NATF(SI) Modification to Centerline-Camera Pit -  
Required Before Camera Could be Installed
